Preparation Ferrule Design Effect on EndoCrown Fracture Resistance

Major Michael L. Einhorn

Dean, Air Force Postgraduate Dental School

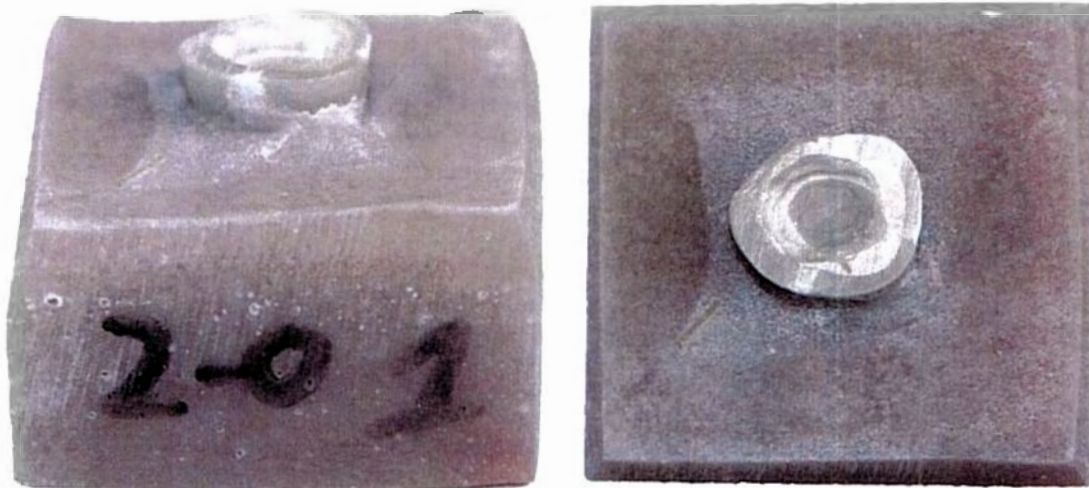
Figure 1, Prepared acrylic embedded specimens

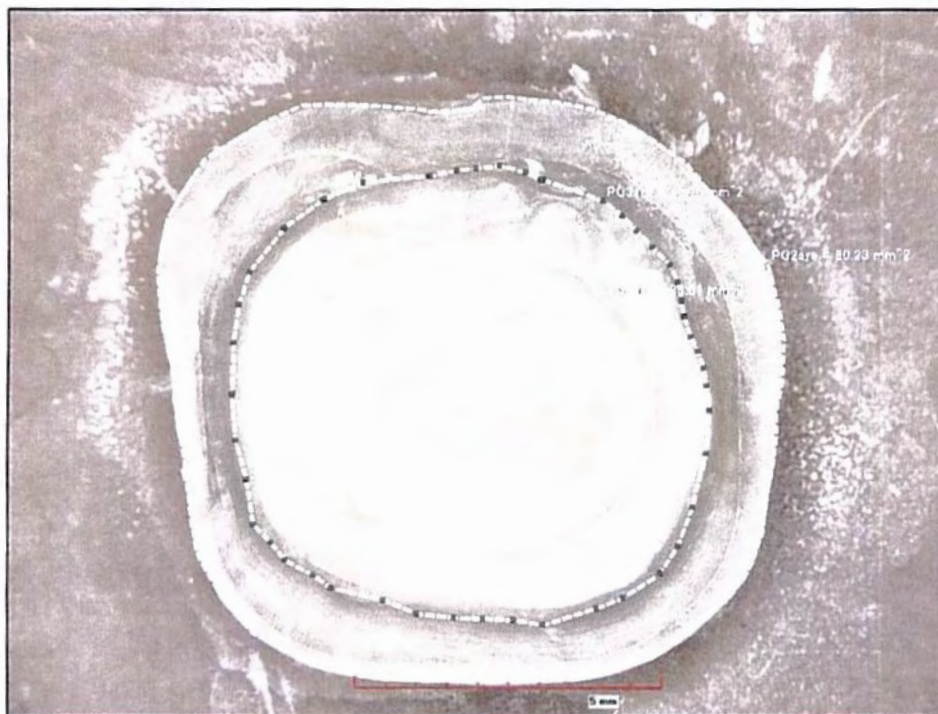
The completed endocrown preparations were then randomly subdivided into three groups ($n = 12$). Two of the groups received ferrule preparation features to the external coronal surface consisting of one and two millimeters placed circumferentially apical to the endocrown occlusal table. The third group did not receive additional preparation features. All specimens had preparation features confirmed and surface area measured using a digital recording microscope (KH- 7700, Hirox USA, Hackensack, NJ, USA). (Figure 2)

Figure 2, Occlusal Table and Margin Surface Area Determination

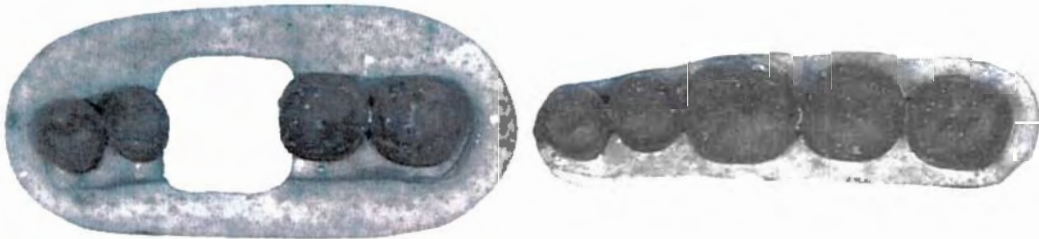
Two identical standardized templates were fabricated using acrylic. The template represented teeth #28 through #31 with one template having tooth #30 removed. (Figure 3) All specimens were scanned and restored using the standardized template (Figure 4) to simulate clinical conditions using a chairside CAD/CAM unit (Cerec AC/Cerec MC XL, Dentsply Sirona, Charlotte, NC, USA; Software version 4.2.4.72301) with the full-coverage restorations milled

Figure 3, CAD/CAM Standardized Scanning Templates

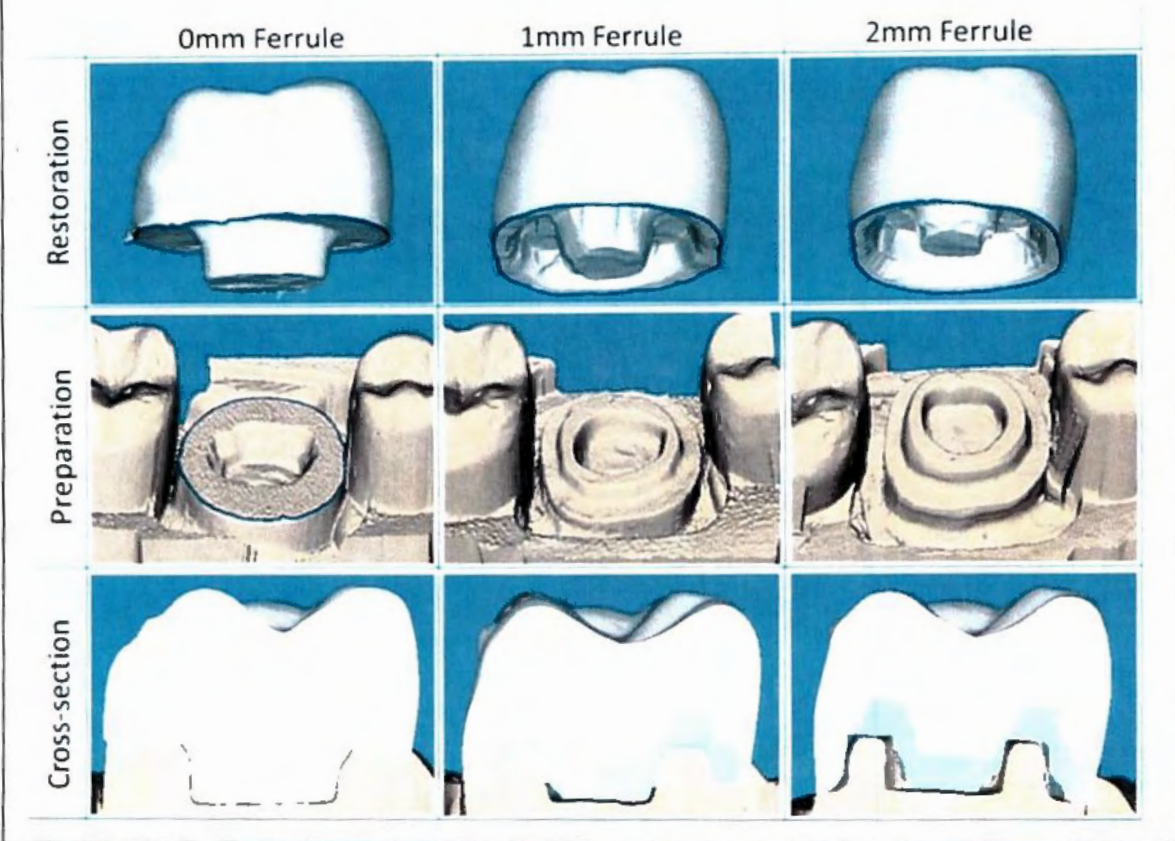
using a lithium disilicate glass-ceramic restorations (IPS e.max CAD, Ivoclar-Vivadent). (Figure 5)

All restorations were designed with identical occlusal table anatomy as well as axial wall height so as not to incorporate different lever action vectors into the testing design.

Figure 5, CAD/CAM Restoration Designs for 0mm, 1mm, and 2mm Ferrule Preparations

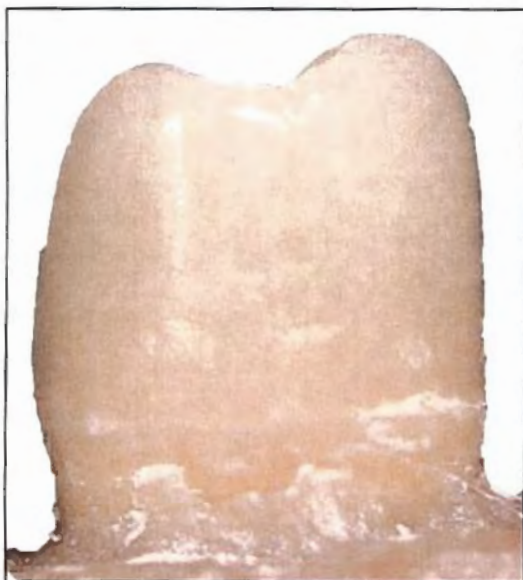
Trail, NC, USA) using a slow-speed handpiece (Midwest Shorty, Dentsply International, York, PA, USA) attachment followed by water rinse and air drying. Restorations were cemented with a self-adhesive resin cement (Rely-X Unicem, 3M ESPE, St. Paul, MN, USA) with firm digital pressure with a one-second tack cure applied to all surfaces using a VLC unit (Bluephase G2, Ivoclar Vivadent) after which excess cement was removed. All surfaces then received a final exposure to a VLC unit (Bluephase G2, Ivoclar Vivadent) for 20 seconds after which the specimens were stored in distilled water under dark conditions at $37 \pm 1^\circ\text{C}$ and $98 \pm 1\%$ humidity. (Figure 6)

Figure 6, Cemented Standardized e.max Restoration

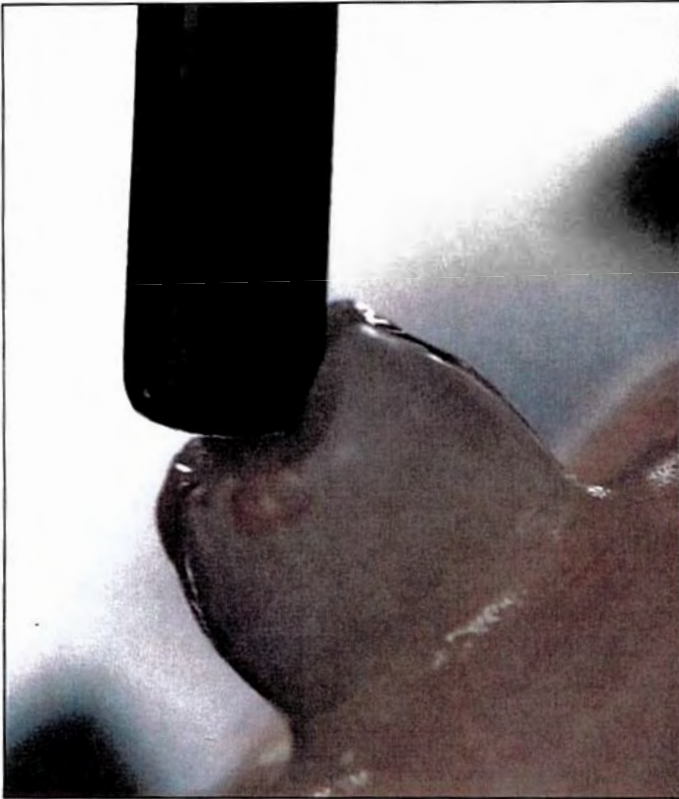
Twenty-four hours after cementation each specimen were placed into a fixture on a universal testing machine (RT-5, MTS Corporation, Eden Prairie, MN, USA) with the long axis of the tooth oriented at a 45 degree angle to the testing device. (Figure 7)

Figure 7, Specimen Testing Orientation

The facial cusps were loaded with a three-millimeter diameter hardened, stainless steel piston with a 0.5-meter radius of curvature as described by Kelly *et al.*¹⁶ Specimens were loaded at a rate of 0.5 millimeter per minute until failure with the failure load recorded in Newtons. Failure load was also converted to failure stress using the measured surface area available for adhesion. Specimens were examined for failure mode to determine if the failure was cohesive for the ceramic restorative material, adhesive failure between the ceramic and the tooth structure, tooth material fracture, or mixed failure. Analysis was accomplished both visually at 20X magnification (Hirox-4400, Hirox USA) as well as microradiographic tomography (microCT) (Skyscan 1172, Bruker microCT/Micro Photonics, Allentown, PA, USA). Fractured samples were scanned over 180 degrees at 9.8-micron resolution with a 0.4 degree step size with aluminum filtration. Resultant individual images were recombined with software (nRecon,

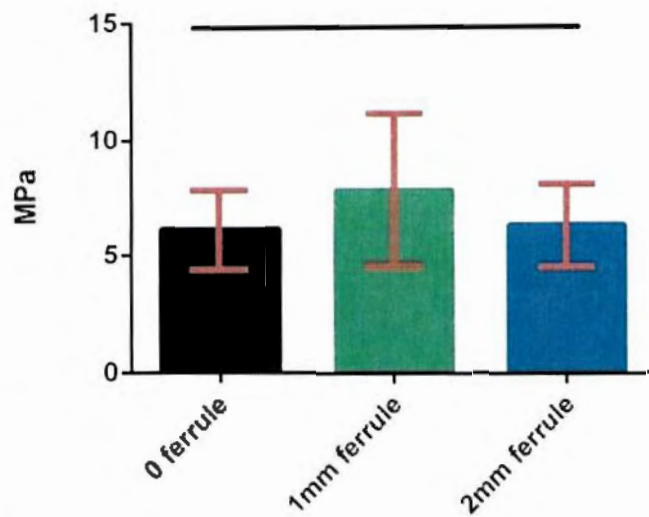
Figure 9. Mean Failure Stress Results (MPa)

n = 12; Items connected by same bar are significantly similar (Kruskal-Wallis, $p = 0.42$)

Under the conditions of this study the calculated failure stress (MPa) found no significant difference noted between the preparation groups ($p = 0.427$). However, analysis using failure load (N) demonstrated a difference between the groups ($p = 0.016$), with *post hoc* testing identified that the ferrule groups were similar with each other ($p = 0.857$) but was significantly greater than the endocrown group ($p = 0.0212$) as depicted in Figure 9 and 10.

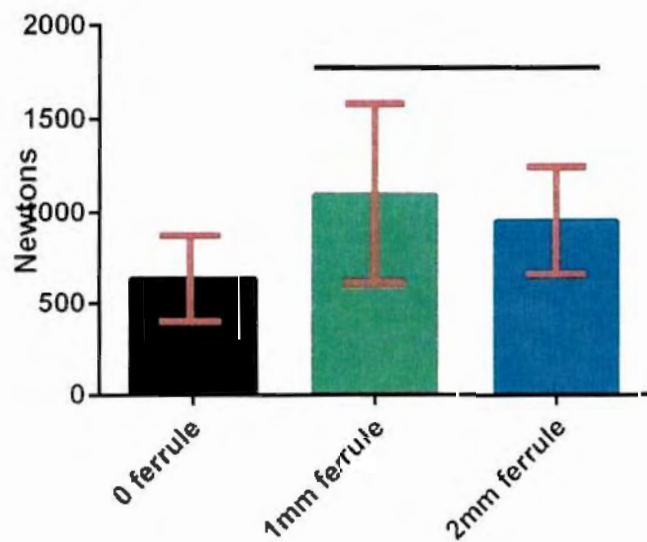
Figure 10. Mean Failure Load Results (N)

n = 12; Items connected by same bar are significantly similar (Kruskal-Wallis/Dunn's, $p = 0.021$)

Therefore, the null hypothesis was rejected under the consideration of failure load, but was accepted when the failure stress data was observed. It is interesting to note that although the available surface for adhesion increased over 47 percent from the standard endocrown to the endocrown with a two millimeter ferrule, no difference in failure stress was noted. However, failure load results identified the ferrule groups failed at significantly greater loads than the standard endocrown restoration.

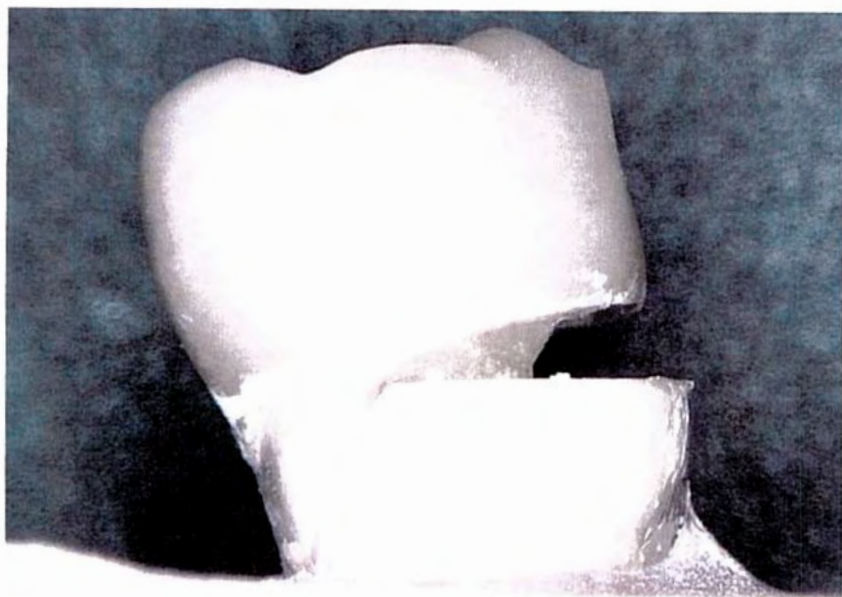
Figure 11. 3D Tiled Image Zero Millimeter Ferrule Failure

The most clinically relevant findings of this study may be noted when the failure analysis results are considered. MicroCT analysis proved to be a valuable tool in assessing the failure modes, as some specimens with visually judged repairable damage (Figure 11) was found to contain irreparable fractures that, depending on location, may or may not be visible on a standard periapical film (Figure 12, Figure 13).

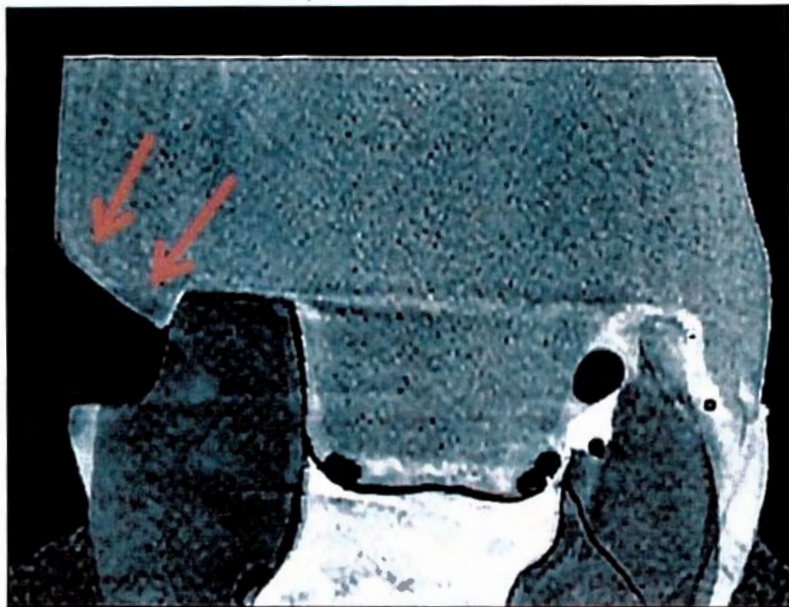
Figure 12. MicroCT Image of 1mm Ferrule – Catastrophic Failure

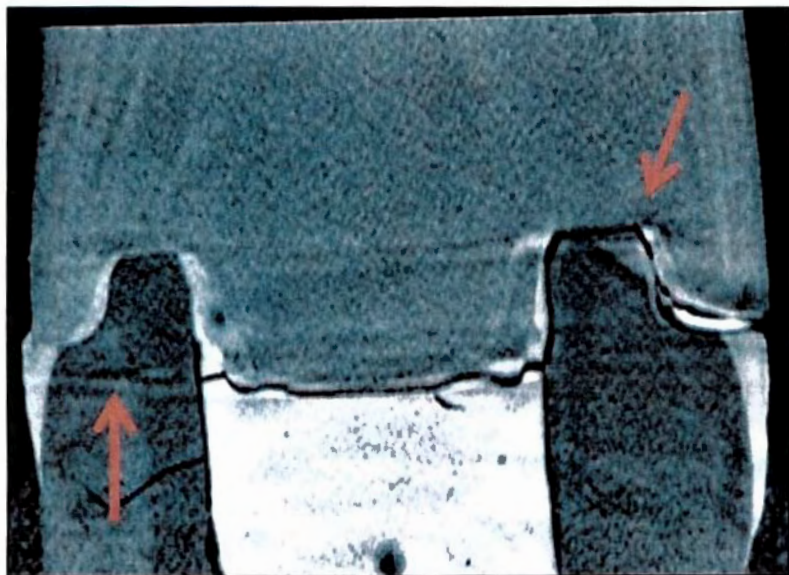
Figure 13. MicroCT Image of 1mm Ferrule – Catastrophic Failure

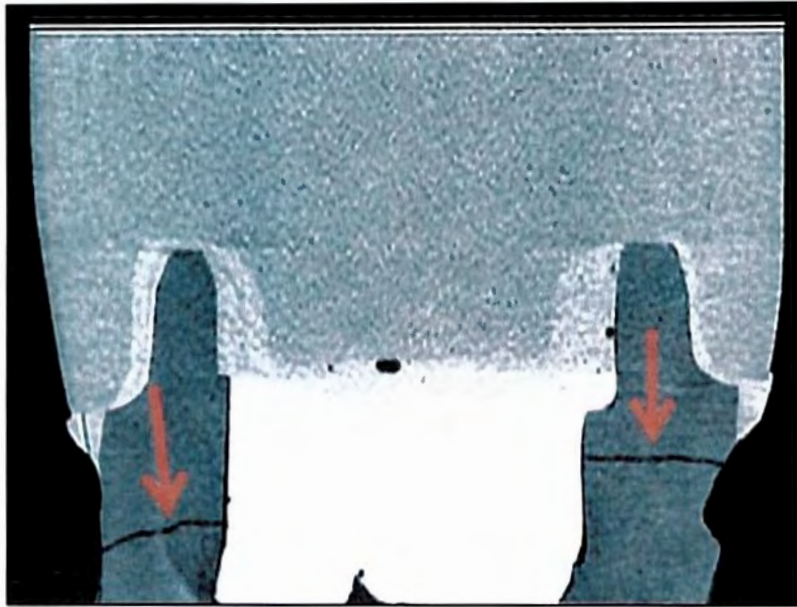
Figure 14. MicroCT Image 2mm Ferrule – Catastrophic Failure

All of the endocrown preparations containing two millimeters of ferrule failed catastrophically, (Figure 14) followed by 10 of the 12 standard endocrown preparations. The one millimeter endocrown ferrule group had the least number of catastrophic failures, albeit with 66 percent of the specimens exhibiting non-restorable fractures. Thus, under laboratory testing the endocrowns, regardless of ferrule preparation features, demonstrated a high percentage of catastrophic failures.

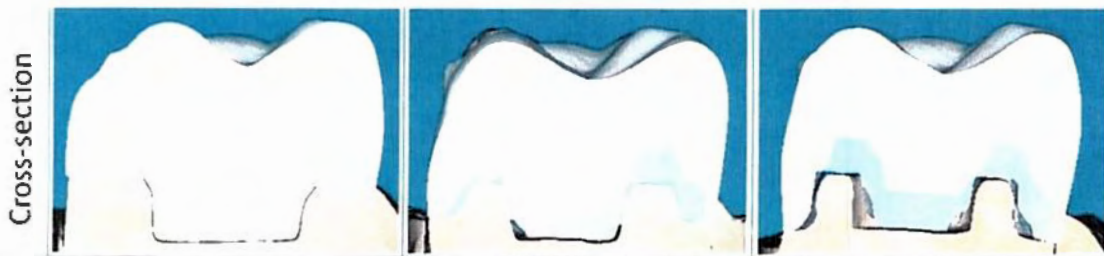
Figure 15. Cross Section of endocrowns with decreased crown adaption

A preparation parameter that was observed that may affect restoration performance was the milling limitations in reproducing the intaglio surface of the crown. Accordingly, it was observed that the more complex the preparation, the more complex the restoration design and therefore resulted in decrease crown adaptation with 1mm and 2mm designs with larger cement space (Figure 15). Another preparation parameter was the sometimes tooth structure limitation realized by a ferrule addition in the cervical area. This resulted in some ferrule areas with limited ferrule wall thickness (Figure 16).

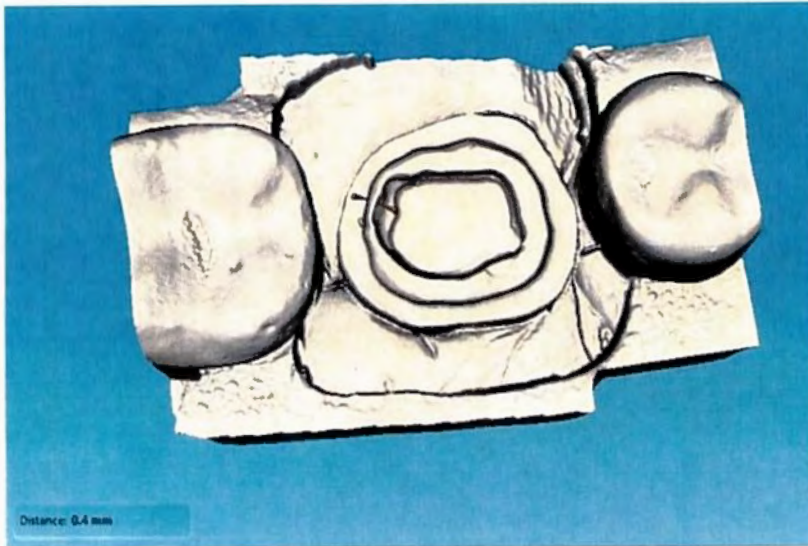
Figure 16. Preparation with deficient tooth structure for ferrule

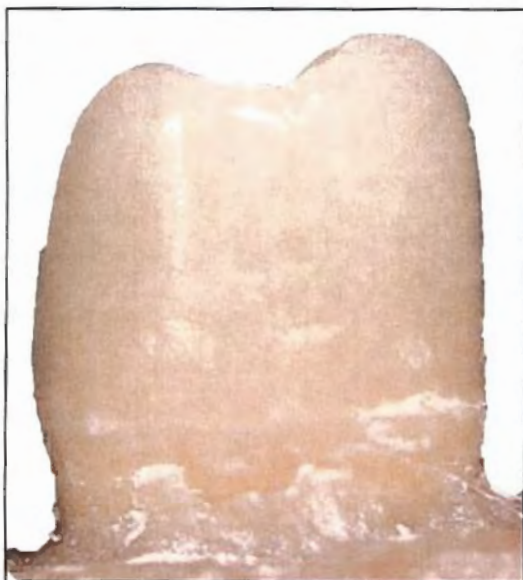
Trail, NC, USA) using a slow-speed handpiece (Midwest Shorty, Dentsply International, York, PA, USA) attachment followed by water rinse and air drying. Restorations were cemented with a self-adhesive resin cement (Rely-X Unicem, 3M ESPE, St. Paul, MN, USA) with firm digital pressure with a one-second tack cure applied to all surfaces using a VLC unit (Bluephase G2, Ivoclar Vivadent) after which excess cement was removed. All surfaces then received a final exposure to a VLC unit (Bluephase G2, Ivoclar Vivadent) for 20 seconds after which the specimens were stored in distilled water under dark conditions at $37 \pm 1^\circ\text{C}$ and $98 \pm 1\%$ humidity. (Figure 6)

Figure 6, Cemented Standardized e.max Restoration

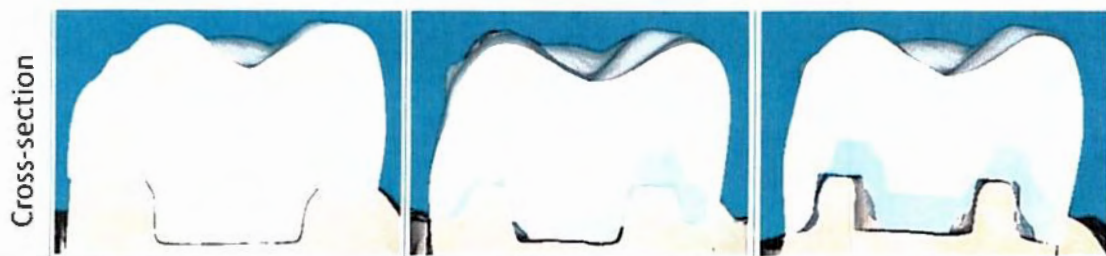
A preparation parameter that was observed that may affect restoration performance was the milling limitations in reproducing the intaglio surface of the crown. Accordingly, it was observed that the more complex the preparation, the more complex the restoration design and therefore resulted in decrease crown adaptation with 1mm and 2mm designs with larger cement space (Figure 15). Another preparation parameter was the sometimes tooth structure limitation realized by a ferrule addition in the cervical area. This resulted in some ferrule areas with limited ferrule wall thickness (Figure 16).

Figure 15. Cross Section of endocrowns with decreased crown adaption

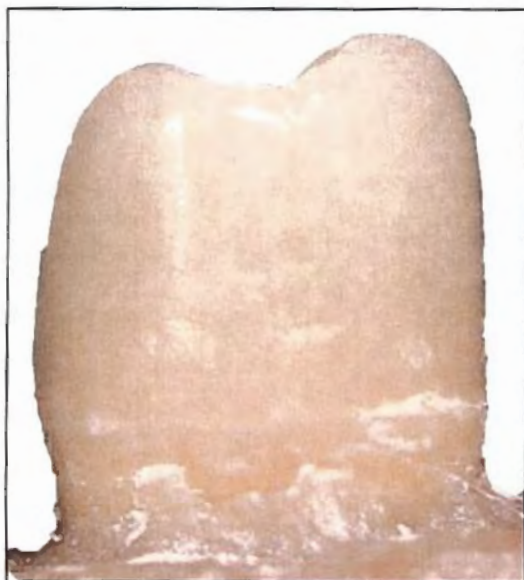
Trail, NC, USA) using a slow-speed handpiece (Midwest Shorty, Dentsply International, York, PA, USA) attachment followed by water rinse and air drying. Restorations were cemented with a self-adhesive resin cement (Rely-X Unicem, 3M ESPE, St. Paul, MN, USA) with firm digital pressure with a one-second tack cure applied to all surfaces using a VLC unit (Bluephase G2, Ivoclar Vivadent) after which excess cement was removed. All surfaces then received a final exposure to a VLC unit (Bluephase G2, Ivoclar Vivadent) for 20 seconds after which the specimens were stored in distilled water under dark conditions at $37 \pm 1^\circ\text{C}$ and $98 \pm 1\%$ humidity. (Figure 6)

Figure 6, Cemented Standardized e.max Restoration
